RAILWAY INVESTIGATION REPORT
R99D0159

RUNAWAY CARS

CANADIAN NATIONAL
MILE 69.4, CN KINGSTON SUBDIVISION
WESCO SPUR
CORNWALL, ONTARIO
27 AUGUST 1999

Report Number R99D0159

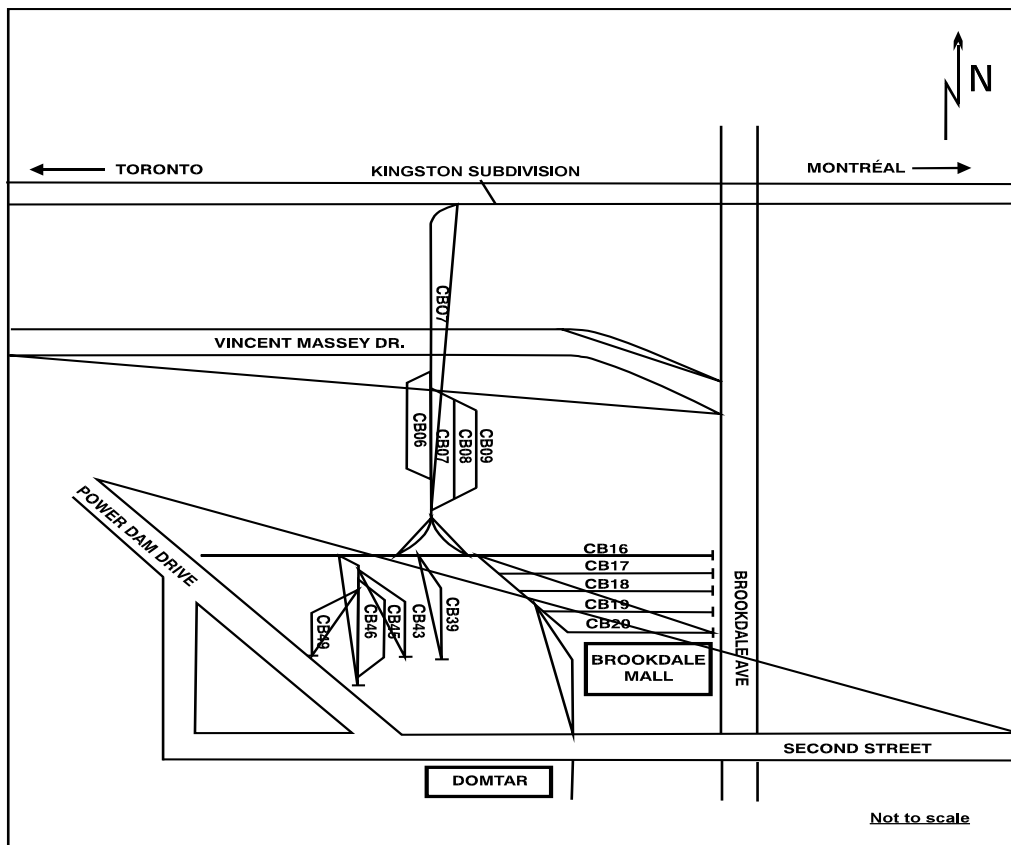
Figure 1 - Layout of Wesco spur and yard CB

Yard CB (see Figure 1) has five storage tracks; it runs east-west through a business area between a shopping centre and a restaurant. The tracks in yard CB are used to store cars awaiting delivery to local companies.

Track CB17 is 1 500 feet long, has a 1 per cent descending grade eastward, and curves slightly left one degree over approximately 1 000 feet starting at the switch. It consists of 85-pound rails laid in 39-foot bolted lengths. It is a dead-end track equipped with an end stop block.

CN has retrofitted the stop blocks and modified the track layout in yard CB at Cornwall. Tracks CB19 and CB20 were removed and the remaining tracks were shortened by 500 feet, thus distancing the storage area from nearby businesses.

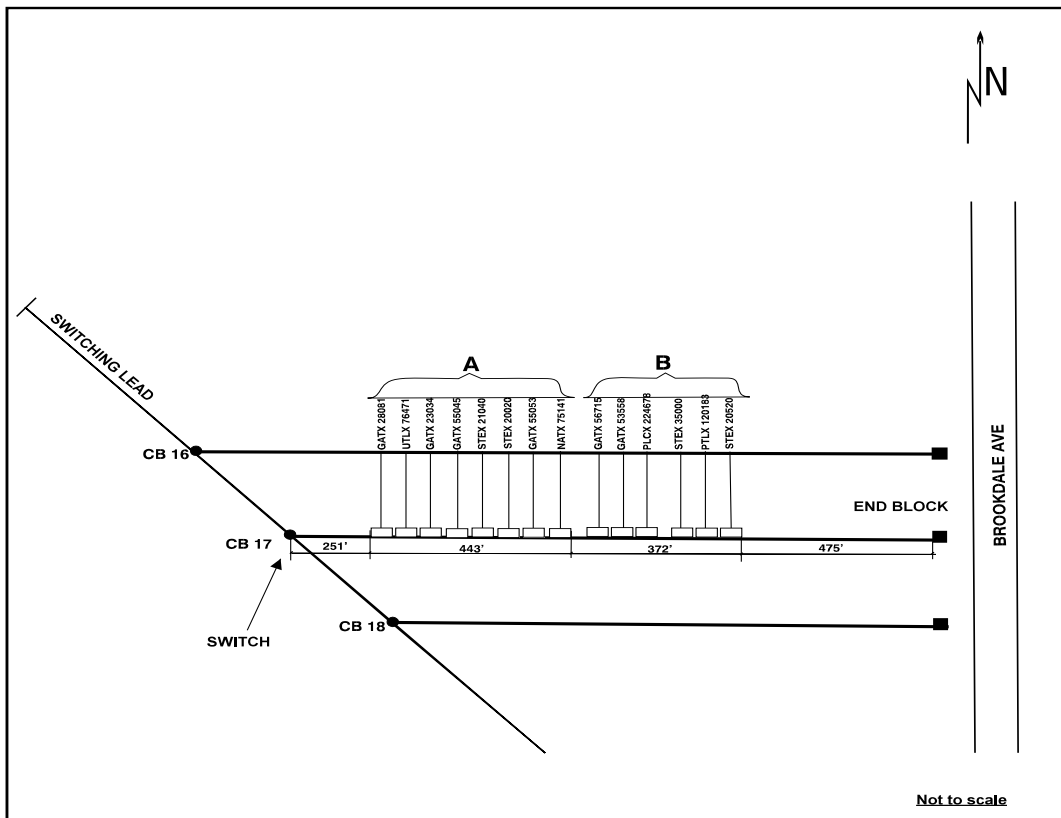
Figure 2 - Arrangement of the cars in drafts A and B

On the day of the accident, the crew had to push a draft of eight cars (draft A) onto the switching lead, place the two leading cars in the draft just ahead of the locomotive, then couple to the six tank cars (draft B) standing at the east end of track CB17 in yard CB (see Figure 2). The 14 cars were then to be delivered to various clients. This was a routine operation typically performed several times a week.

Draft A was 443 feet long and was standing 251 feet from the switch (see Figure 2). With the six cars coupled, draft B was 356 feet long. The marks made by the wheels of car STEX 20520 indicate that the east end of draft B was 475 feet from the stop block; therefore, draft B only had 372 feet. Since the cars in draft B were not in cuts, the theoretical maximum distance between draft A and draft B must have been less than 16 feet.

1. Theoretically, there was only 16 feet to manoeuvre between draft A and draft B. It was difficult to avoid contact between the drafts without a crew member controlling the movement.
